Marathon F1-F2 Tornado

Friday Morning, August 25th 2005

Survey Report

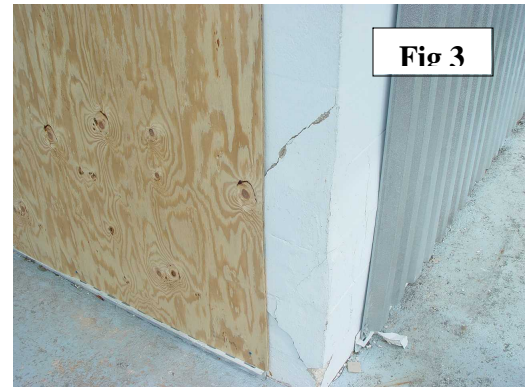
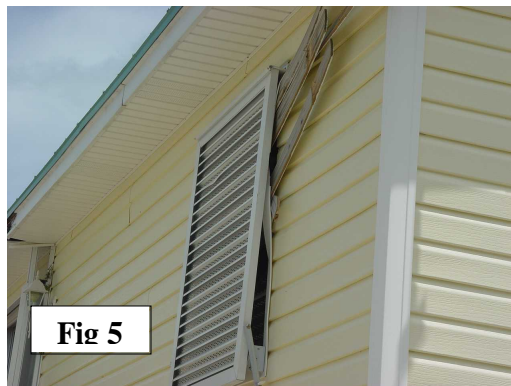
From 74th Street Ocean through W 75th Street Ocean, the tornado appeared to intensify somewhat. More missile damage was evident, and there was substantial damage to at least two houses, as well as one trailer severely damaged. Power lines were downed, and at least one utility pole snapped. A house on 74th Street Ocean, belonging to Mike Card (see witness testimony) was twisted on its foundation, causing the masonry to crack at all four corners of the house (Fig 3). Additionally, the shutters were ripped off one of Mr. Card's windows, and the window shattered (Fig 3). Across the canal, at 944 W 75th Street (see witness testimony), the porch was destroyed, and several fence boards, of an unknown origin, embedded between the window frame and the siding of the house (shattering the window). The shutter was closed when this occurred (Figures 4 and 5).

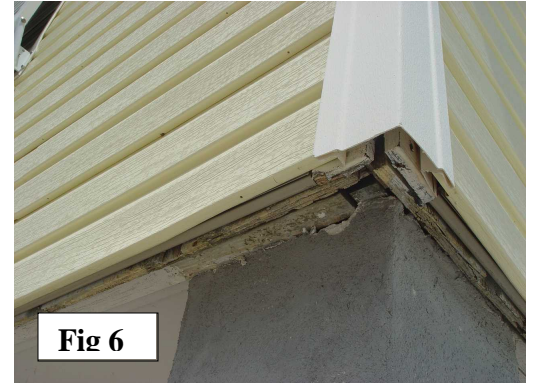
Fig 6

The porch of this residence was also destroyed, with the aluminum roof and all siding and screens removed. Several of the planks which comprised the porch floor were also missing. After interviewing the resident, it was discovered that the house had been shifted on its pilings; either pushed or lifted and dropped (Figure 6). Later, independent of this survey, it was discovered that the roof had been separated from the walls. Given the missile damage and the structural damage evident, it appeared that the tornado had reached F1 intensity during this portion of the path. The path width at this point also appears to have expanded, as best could be determined, reaching approximately 50 yards.

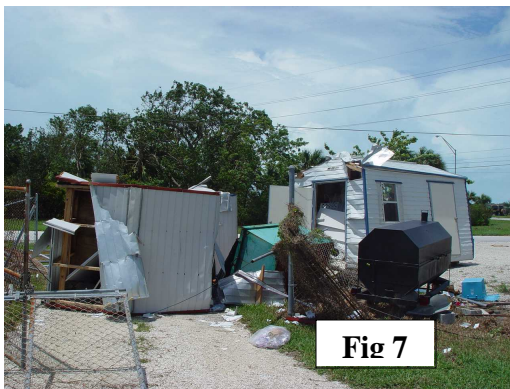
Fig 7

From W 75th Street Ocean, the tornado continued towards the north northeast, moving over a children's park causing some tree damage, then moving just east of 76th Street Ocean and the Overseas Highway impacting two businesses. General Rental, on the southeast corner of 76th Street Ocean and the Overseas highway, received damage to a fence, roof, and several sheds which had been tied down and anchored (Figure 7). The sheds were picked up and dropped an estimated 30 to 50

Keith Gustafson, owner of General Rental, showed the survey team where three large sheds, which had been tied down and anchored, had picked up and dumped 30 to 50 feet from their point of origin.

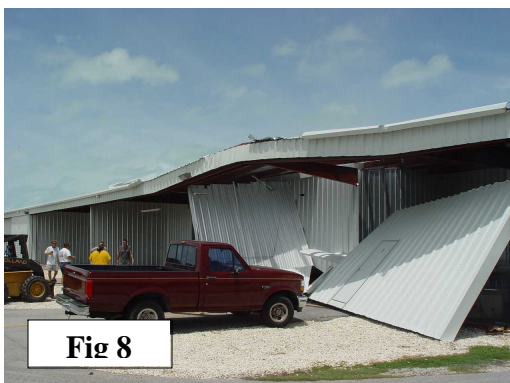
Fig 8

The tornado crossed the Overseas Highway and damaged several hangers at the Marathon Airport. The recently built hangers, which according to one witness on scene where built to withstand category five winds, suffered minor to substantial damage, with the western most hanger receiving heavy damage. This hanger had all but one of its doors damaged and toppled, roof damage, and three large steel I-beams bent (figures 8 and 9). Estimated wind to cause this type of damage, and to bend the I-bean infrastructure, are near 120 mph. This would be consistent with a weak F2 tornado.

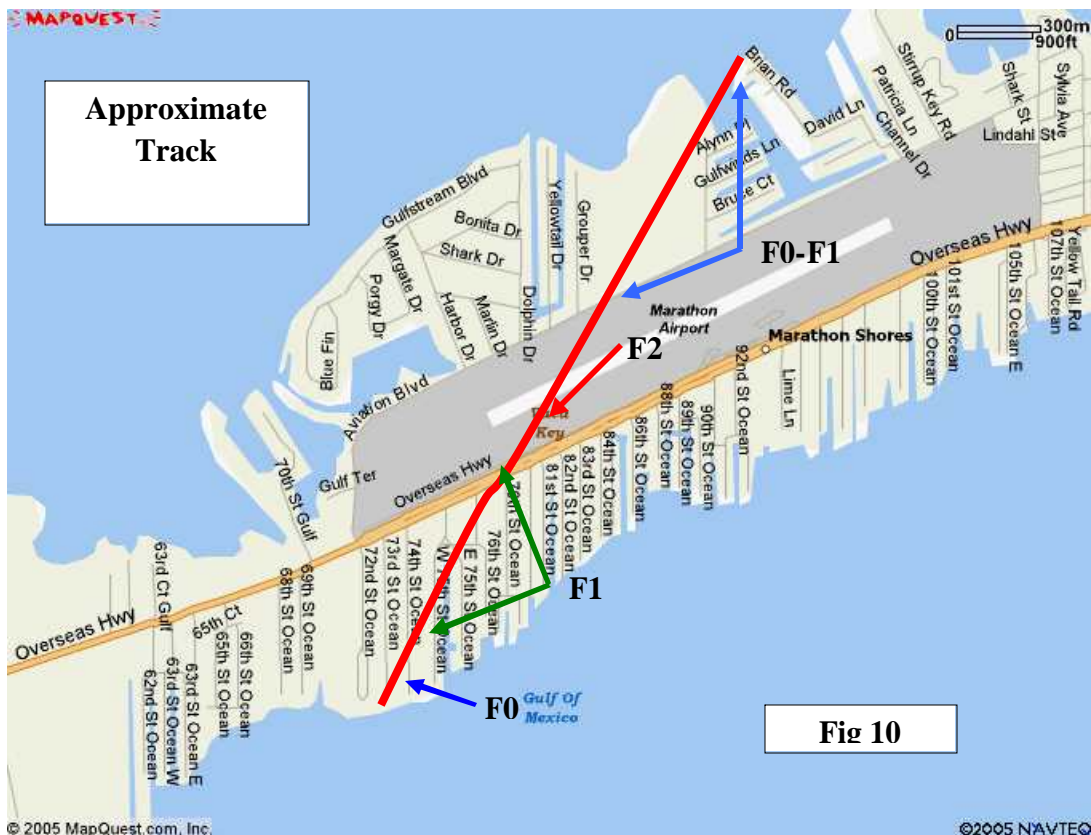
A very discrete, narrow track was uncovered during the survey (Figure 10) . Damage, if any, outside of the tornado track was minimal, and could be explained as a result of the ambient tropical storm force winds. At times along the path, strong F1 to weak F2 damage was apparent. The debris field was very convergent, with some debris deposited along the track traceable to points of origin as far as 1,200 feet away. Given the convergent debris field, missile damage, long track, and the apparent strengthening of the tornado from 74th Street Ocean to the Marathon Airport, a convectively induced downburst was ruled out as a cause of the damage. However, some type of shear zone, such as a gust front along a convective downburst, could certainly have been the larger scale mechanism that spawned the tornado. Some of the witness testimony might also support this, with reports along the Ocean side reporting a loud boom and pressure change which would be consistent with a downburst, with witness further along the track describing an increasing noise, or roaring sound. After consultation with Jon Rizzo, the Warning Coordination Meteorologist at NWS Key West, survey team member Andy Devanas concluded that the event was a F1 tornado, with a limited area of F2 damage.
